MASTER / PILOT EXCHANGE PROCEDURES

Maritime Mutual Risk Bulletin No. 1

07 November 2018

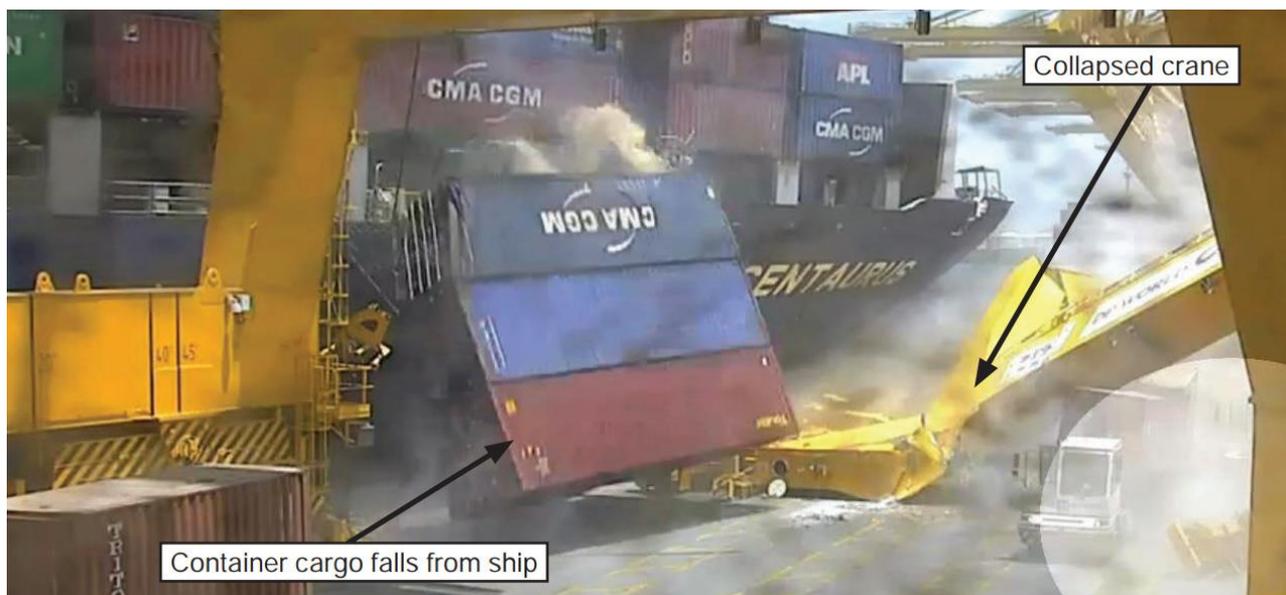
The transfer of the conduct ('the con') of a vessel from the Master to a Pilot remains a mysterious exercise to most non-seafarers. Regrettably, despite clear IMO Res. A.960 (23) guidance on how this critically important process is to be safely accomplished, it still appears to be a mystery to many Shipmasters and Pilots as well. The results of an inadequate transfer and the consequent destruction of jetty container cranes by the containership "CMA CGM Centaurus" at Jeb Ali, UAE, are illustrated by the above photo as contained in a recently released MAIB report.

As captured on [Video](#), the bow of the "Centaurus" struck the jetty causing severe damage to the ship's hull, the complete destruction of a jetty container crane and damage to another. Ten shore personnel were injured, one of them seriously. Claims for hull repairs, crane repairs and a complete replacement, as well as extensive downtime and loss of earnings for both parties, cost tens of millions of dollars.

The [MAIB's full report](#) is carefully documented and illustrated but is not permitted to find fault or apportion blame. However, the reasonable inference must be that both the Pilot and the Master were negligent in failing to comply with [IMO Res A.960 \(23\) Annex 2](#) and the ICS publication, [Bridge Procedures Guide](#) (5th Ed). The Master was also negligent in not complying with CMA CGM's stipulated Master/Pilot exchange procedures. If these guidelines and procedures had been followed, so that the Pilot, Master and OOW were enabled to work together as a co-ordinated Bridge Team, then the likelihood is that this very costly incident would not have occurred.
