FUEL OIL LEAKS AND ENGINE ROOM 'HOT SPOTS': PRO-ACTIVE DETECTION AND FIRE AVOIDANCE

Maritime Mutual Risk Bulletin No. 72

August 1, 2023

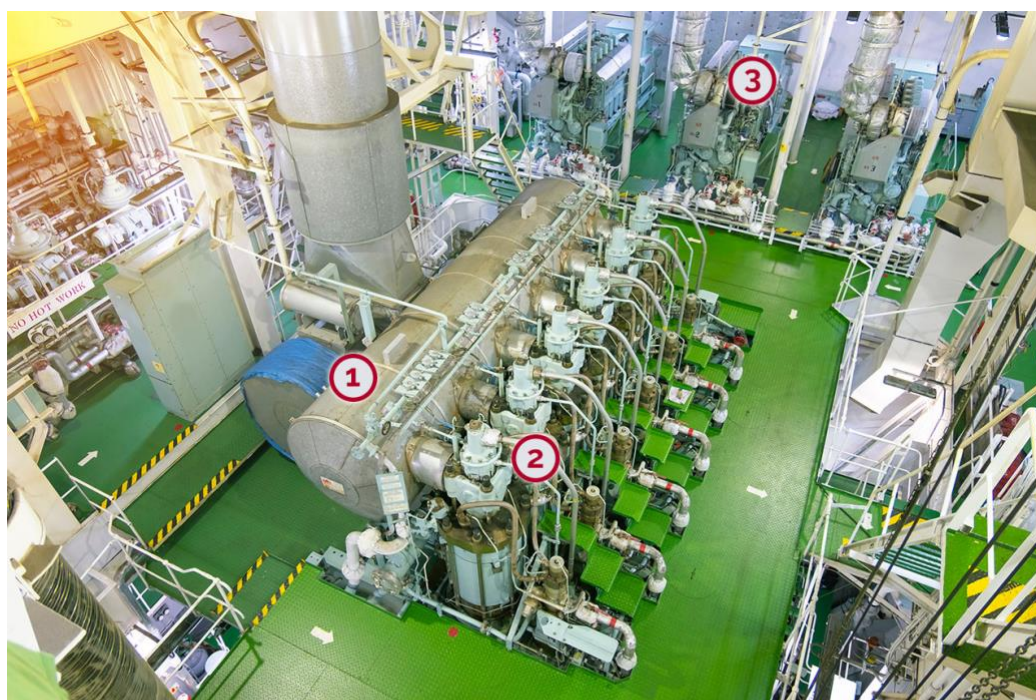
- ① Main Engine hot surface exhaust casing and turbo charger.
- ② Main engine high pressure fuel lines and injectors.
- ③ Auxiliary diesel generator units.

Top view of a large vessel's main diesel engine. Note proximity between the high pressure fuel oil piping and cylinder injector system and the hot surface exhaust casing and turbo charger unit. The three auxiliary diesel generator engines also present similar oil spray and hot surface risks.
