MASTER / PILOT EXCHANGE PROCEDURES

Maritime Mutual Risk Bulletin No. 1

07 November 2018

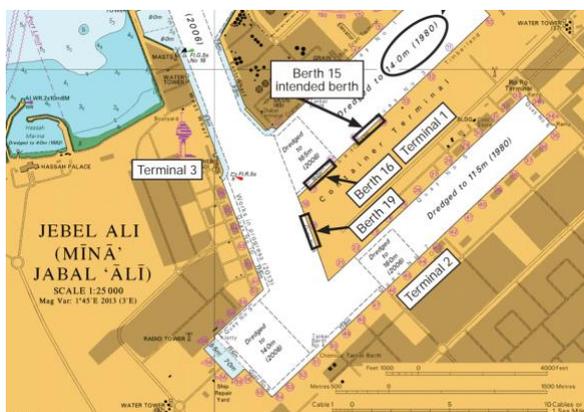
The Master/Pilot exchange was totally inadequate and not in compliance with IMO Res. A.960 (23) or ICS published guidelines. Nor did it comply with CMA CGM's navigation and pilotage procedures as incorporated into the ship's manual. As a consequence, there was no confirmation of the roles of the full Bridge Team, inclusive of acquiring and sharing navigational information with the Pilot.

Instead, the Pilot took not only just 'the con' of the vessel but also complete control of her navigation with the Bridge Team acting as little more than bystanders. Thus, when he later attempted a 90° turn to port (at a relatively high speed of 7 knots) into the designated berth basin, neither the Master nor any other member of the Bridge Team were capable of challenging the Pilot's decision or timing.

Quickly realising that he had started the turn too late and at too high a speed, the Pilot made frantic attempts to recover using the helm, main engine and the two tugs under his control. Too little, too late.

As captured on [Video](#), the bow of the "Centaurus" struck the jetty causing severe damage to the ship's hull, the complete destruction of a jetty container crane and damage to another. Ten shore personnel were injured, one of them seriously. Claims for hull repairs, crane repairs and a complete replacement, as well as extensive downtime and loss of earnings for both parties, cost tens of millions of dollars.

The [MAIB's full report](#) is carefully documented and illustrated but is not permitted to find fault or apportion blame. However, the reasonable inference must be that both the Pilot and the Master were negligent in failing to comply with [IMO Res A.960 \(23\) Annex 2](#) and the ICS publication, [Bridge Procedures Guide](#) (5th Ed). The Master was also negligent in not complying with CMA CGM's stipulated Master/Pilot exchange procedures. If these guidelines and procedures had been followed, so that the Pilot, Master and OOW were enabled to work together as a co-ordinated Bridge Team, then the likelihood is that this very costly incident would not have occurred.
