PILOT LADDER TRANSFERS: SPECIAL RISKS DEMAND SPECIAL PRECAUTIONS

Maritime Mutual Risk Bulletin No. 59

June 30, 2022

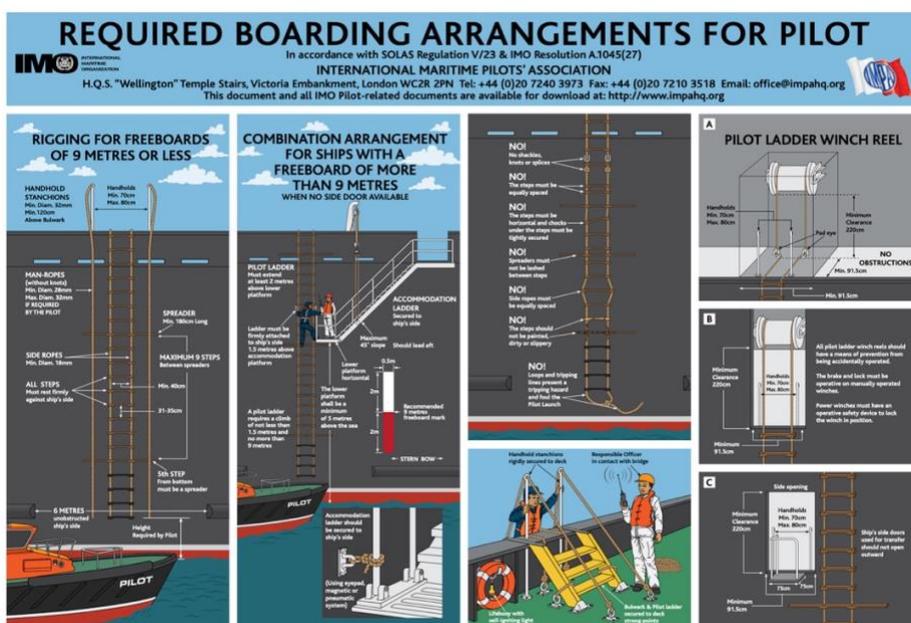
SOLAS Chap V Reg 23 and IMO Resolution A.1045 (27) and Resolution A.1108(29) provide the mandatory pilot boarding arrangements. This includes rigging pilot ladders (for a vessel with a freeboard of 9 m. or less) and rigging a combined pilot ladder and gangway (for a freeboard of 9 m. or more). A ready reference and visual summary of the aforesaid requirements is depicted in the International Marine Pilot's Assoc. (IMPA) poster shown below.

The IMPA poster should be prominently displayed on board every vessel utilising pilot ladders for pilot, crew and other personnel transfers. Some of the key information it illustrates includes:

- Construction of a pilot ladder, including rope size and wood step dimensions and spacing.
- Requirement for wood spreaders – including spacing and minimum width – to prevent the ladder from twisting when being climbed.
