# ‘ON-LOAD’ RELEASE HOOKS FOR DAVIT LAUNCHED LIFEBOATS: “USE WITH CAUTION!”

Maritime Mutual Risk Bulletin No. 17

29 July 2019

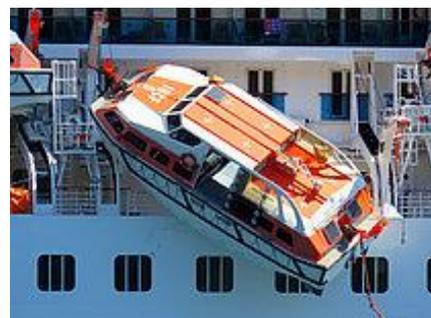
Since the SOLAS mandated introduction in 1986 of ‘on-load’ release hooks, numerous crew member injuries and many deaths have been suffered during the emergency drill launching and retrieval of davit mounted lifeboats. The accident depicted in the thumbnail image appears to be a davit winch failure and not an ‘on-load’ hook failure. However, it serves to illustrate the potential for sudden tragedy. This MM Risk Bulletin is therefore focused on raising MM member awareness of the very serious
